CYCSA Yorke Peninsula St Vincent Gulf Mooring Inspection

Inspection month: October 2023

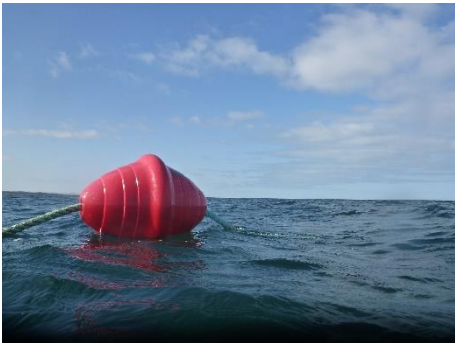
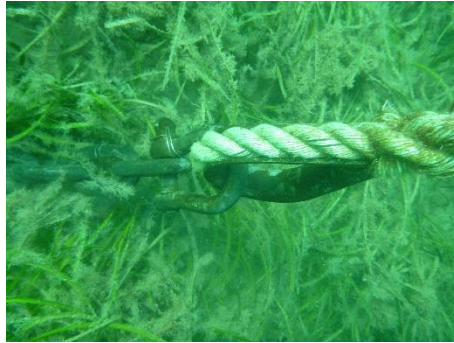
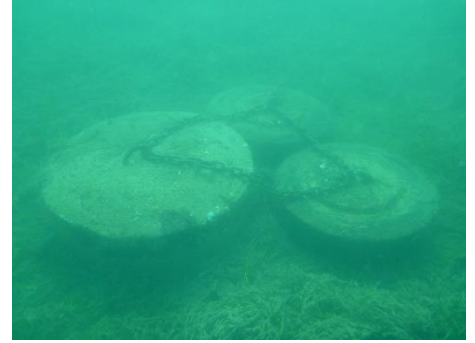
North (previously South West (new location))

Description: 2 truck tires filled with concrete (approximately 400 to 450 kgs each) and 1 concrete mooring (existing, approx. 850kg), 12m of 20mm chain (galv), 15m of 32mm green supertec rope, 1 rope weight. Red mooring buoy with silver "CYCSA" text painted. All components are in good condition. Mooring was moved to deeper water. Rope and buoy were cleaned.

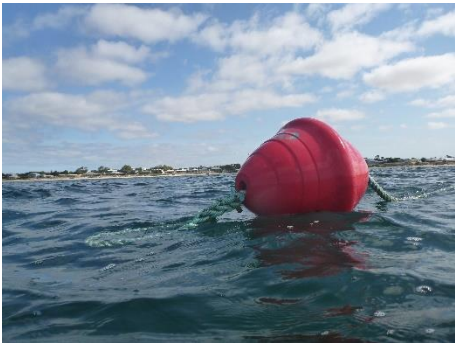
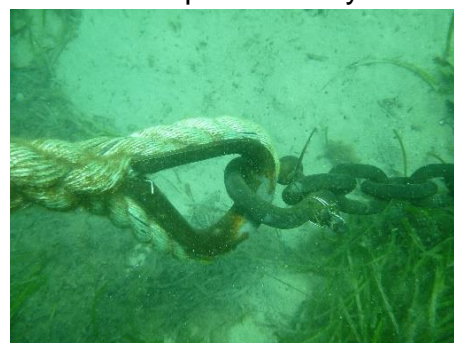
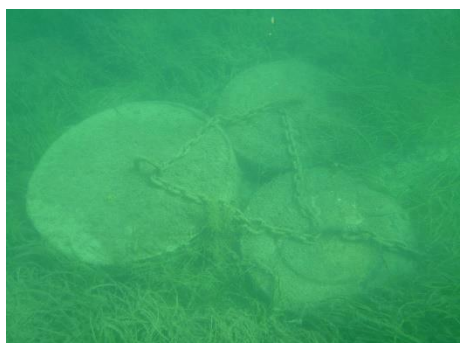
South West (previously North)

Description: 2 truck tires filled with concrete (approximately 400 to 450 kgs each) and 1 concrete mooring (existing, approx. 850kg), 12m of 20mm chain (galv), 15m of 32mm green supertec rope, 1 rope weight. Red mooring buoy with silver "CYCSA" text painted. All components are in good condition. Rope and buoy were cleaned.

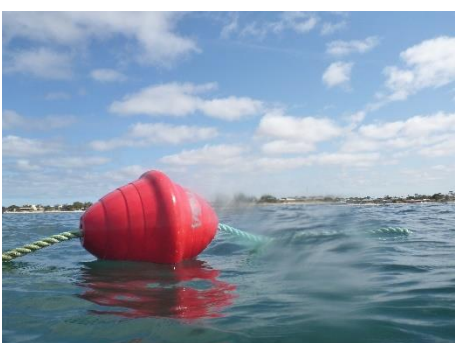
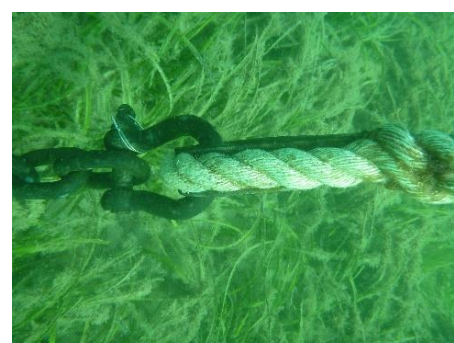
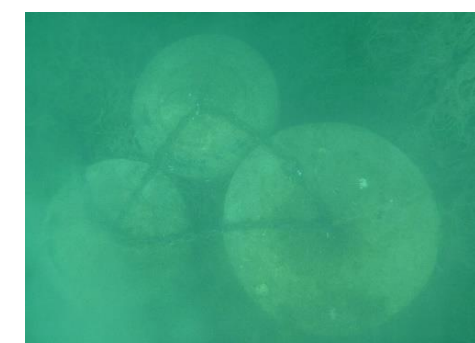
South East (previously South East (new location)) –

Description: 2 truck tires filled with concrete (approximately 400 to 450 kgs each) and 1 concrete mooring (existing, approx. 850kg), 12m of 20mm chain (galv), 15m of 32mm green supertec rope, 1 rope weight. Red mooring buoy with silver "CYCSA" text painted. All components are in good condition. Mooring was moved to deeper water. Rope and buoy were cleaned.

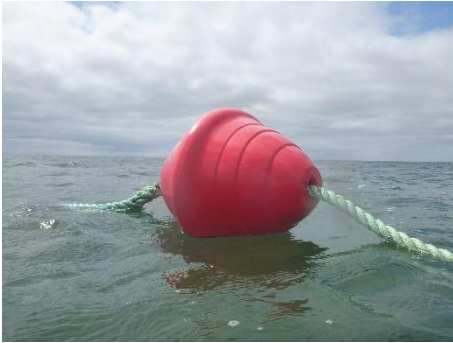
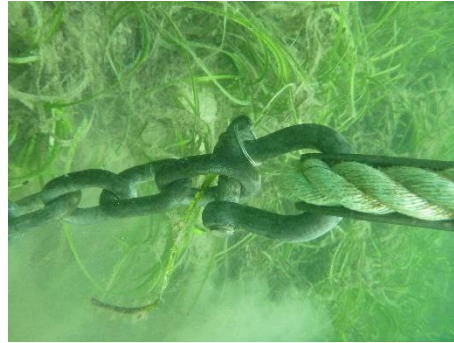
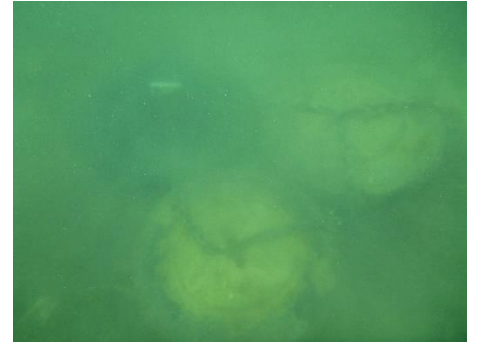
North (previously North (new location))

Description: 2 truck tires filled with concrete and 1 train wheel (existing) (approximately 400 to 450 kgs each). 12m of 20mm chain (galv), 15m of 32mm green supertec rope, 1 rope weight. Red mooring buoy with silver "CYCSA" text painted. 1 anode on existing train wheel loop was replaced. All components in good condition. Mooring was moved to deeper water. Rope and buoy were cleaned.

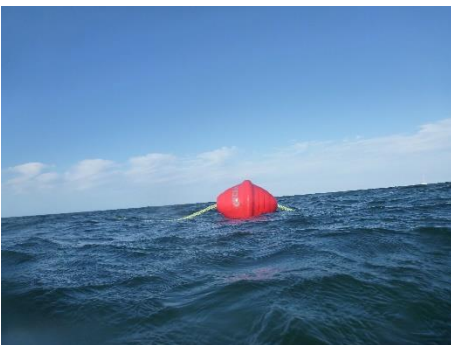
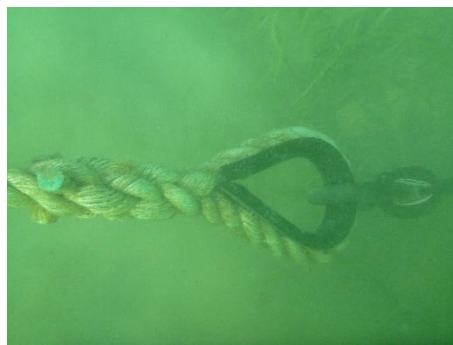
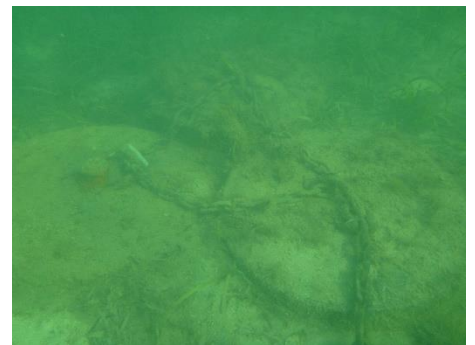
South (previously South East)

Description: 2 truck tires filled with concrete and 1 train wheel (existing) (approximately 400 to 450 kgs each). 12m of 20mm chain (galv), 15m of 32mm green supertec rope, 1 rope weight. Red mooring buoy with silver "CYCSA" text painted. 1 anode on existing train wheel loop still serviceable. All components in good condition. Rope and buoy were cleaned.

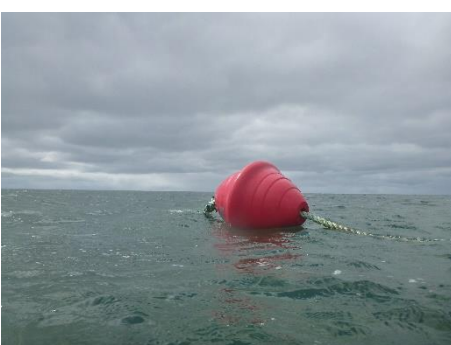
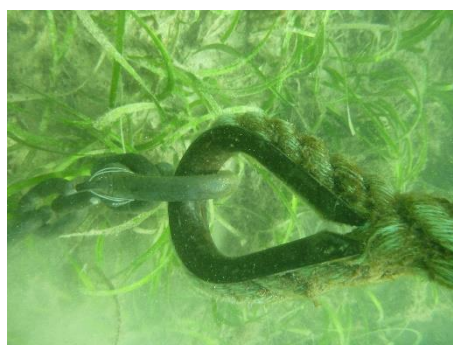
Mid (previously South West (new location))

Description: 2 truck tires filled with concrete and 1 train wheel (existing) (approximately 400 to 450 kgs each). 12m of 20mm chain (galv), 15m of 32mm green supertec rope, 1 rope weight. Red mooring buoy with silver "CYCSA" text painted. 1 anode on existing train wheel loop replaced. All components are in good condition. Mooring was moved to deeper water. Rope and buoy were cleaned.

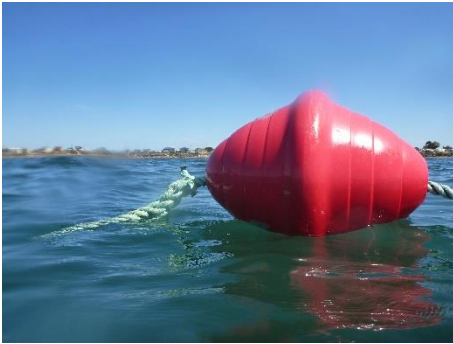
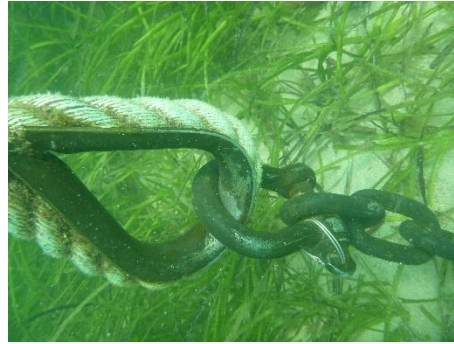
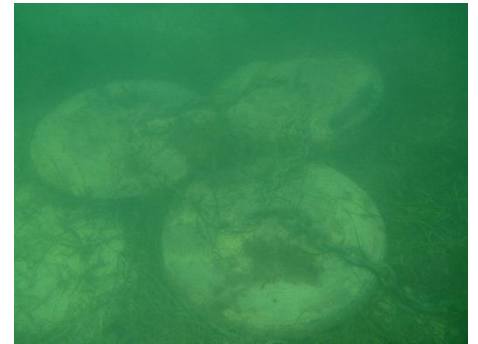
North

Description: 3 truck tires filled with concrete (approximately 400 to 450 kgs each). 12m of 20mm chain (galv), 15m of 32mm green supertec rope, 1 rope weight. Red mooring buoy with silver "CYCSA" text painted. All components are in good condition. Rope and buoy were cleaned.

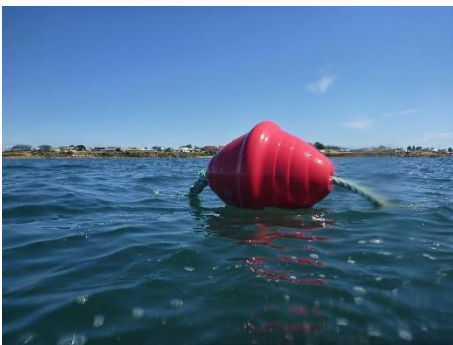
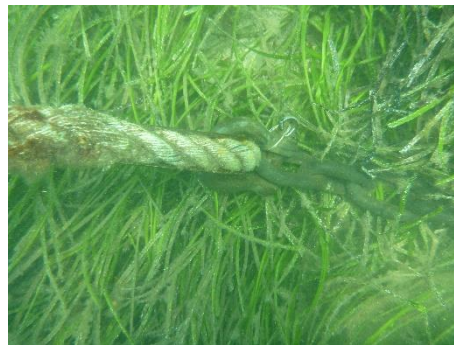
Mid

Description: 3 truck tires filled with concrete (approximately 400 to 450 kgs each). 12m of 20mm chain (galv), 15m of 32mm green supertec rope, 1 rope weight. Red mooring buoy with silver "CYCSA" text painted. All components are in good condition. Rope and buoy were cleaned.

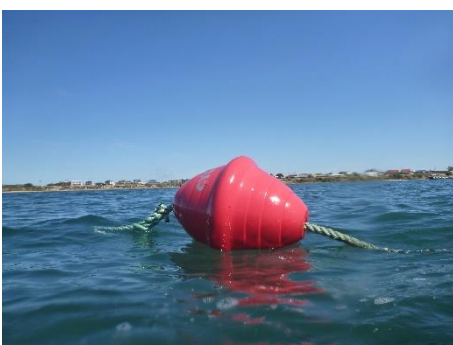
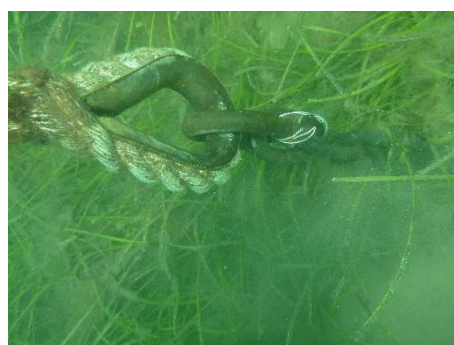
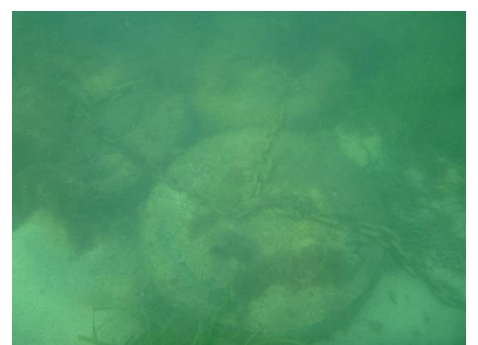
South

Description: 3 truck tires filled with concrete (approximately 400 to 450 kgs each). 12m of 20mm chain (galv), 15m of 32mm green supertec rope, 1 rope weight. Red mooring buoy with silver "CYCSA" text painted. All components are in good condition. Rope and buoy were cleaned.
