# CYCSA Yorke Peninsula St Vincent Gulf Mooring Inspection

Inspection month: October/November 2024

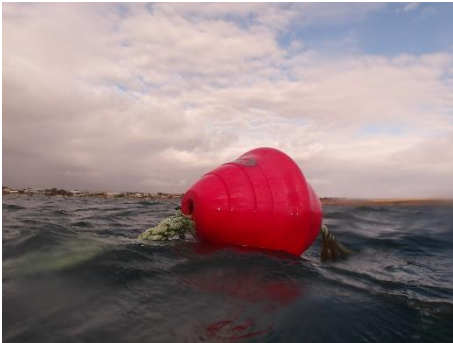
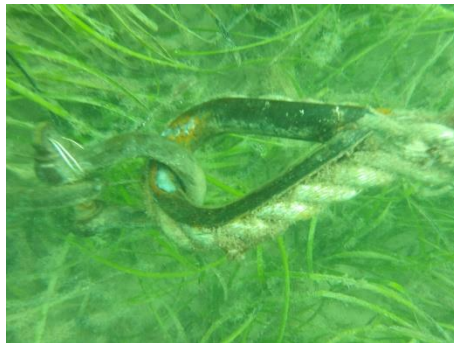
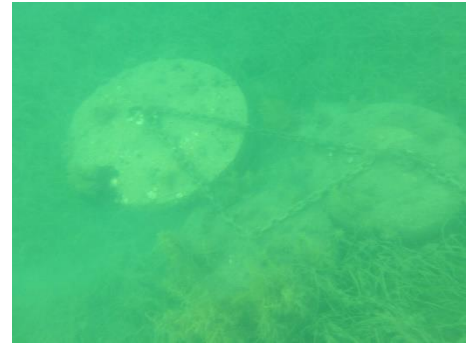
### North

**Description:** 2 truck tires filled with concrete (approximately 400 to 450 kgs each) and 1 concrete mooring (approx. 850kg), 12m of 20mm chain (galv), 15m of 32mm green supertec rope, 1 rope weight. Red mooring buoy with silver "CYCSA" text painted. All components are in good condition. Rope and buoy were cleaned.

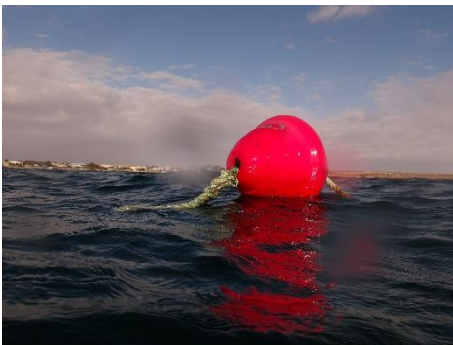
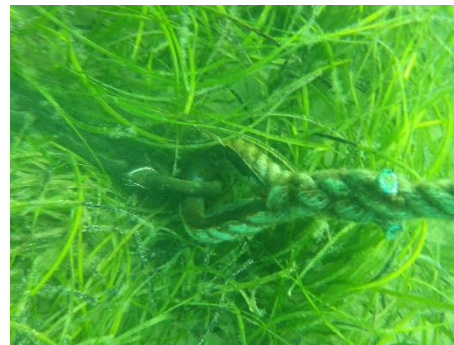
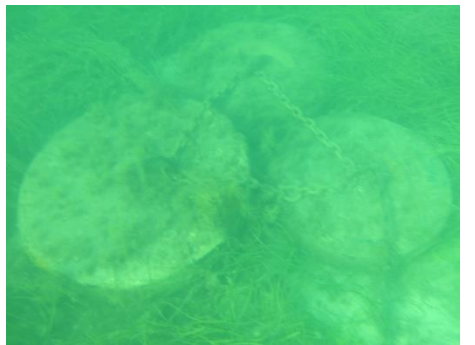
### South West

**Description:** 2 truck tires filled with concrete (approximately 400 to 450 kgs each) and 1 concrete mooring (approx. 850kg), 12m of 20mm chain (galv), 15m of 32mm green supertec rope, 1 rope weight. Red mooring buoy with silver "CYCSA" text painted. All components are in good condition. Rope and buoy were cleaned.

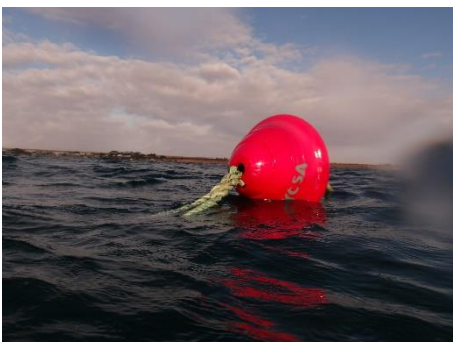
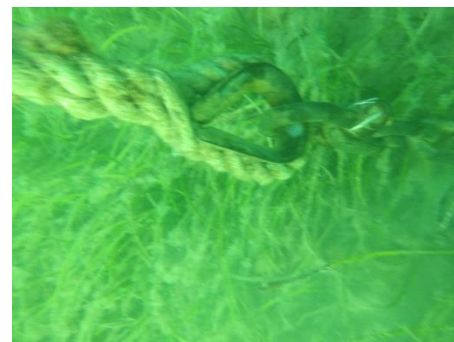
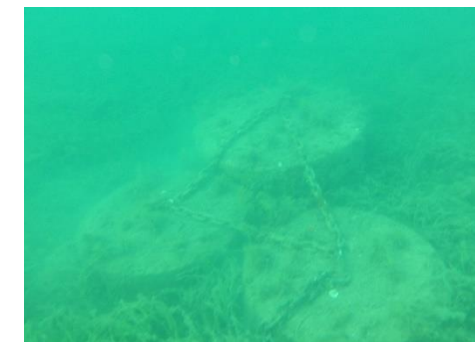
### South East

**Description:** 2 truck tires filled with concrete (approximately 400 to 450 kgs each) and 1 concrete mooring (approx. 850kg), 12m of 20mm chain (galv), 15m of 32mm green supertec rope, 1 rope weight. Red mooring buoy with silver "CYCSA" text painted. Rope and buoy were cleaned.

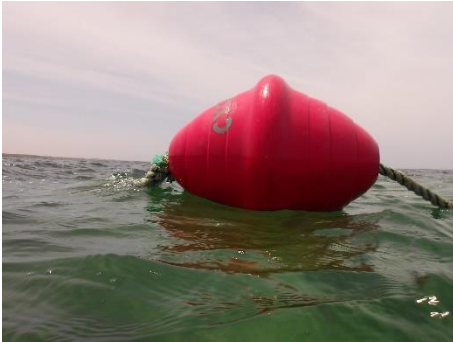
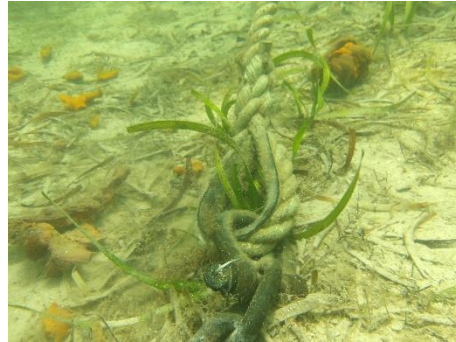
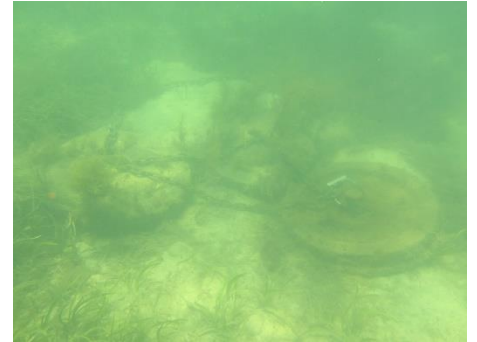
## North

**Description:** 2 truck tires filled with concrete and 1 train wheel (existing) (approx. 400 to 450 kgs each). 12m of 20mm chain (galv), 15m of 32mm green supertec rope, 1 rope weight. Red mooring buoy with silver "CYCSA" text painted. 1 anode on the existing train wheel loop was replaced. All components are in good condition. Rope and buoy were cleaned. Consider replacing train wheel with truck tire filled with concrete as train wheel loops deteriorating.

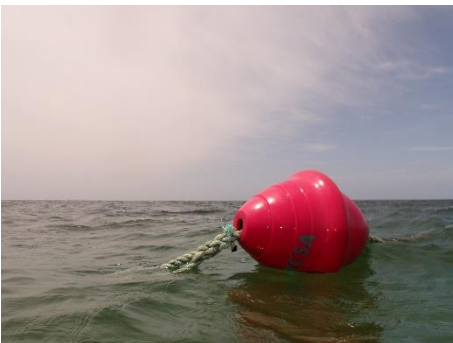
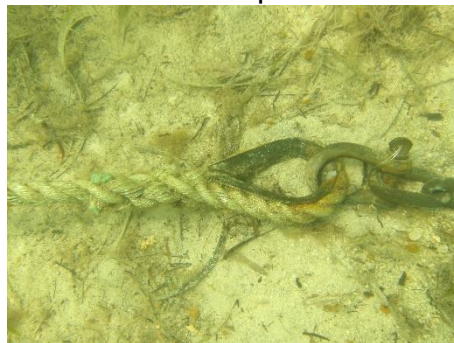
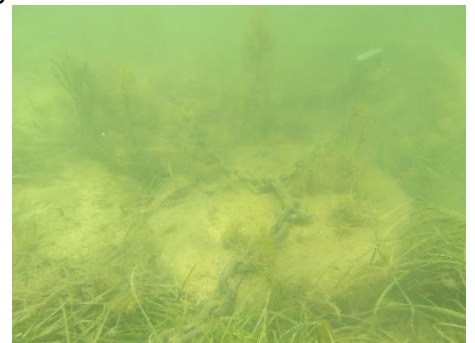
## Mid

**Description:** 2 truck tires filled with concrete and 1 train wheel (existing) (approx. 400 to 450 kgs each). 12m of 20mm chain (galv), 15m of 32mm green supertec rope, 1 rope weight. Red mooring buoy with silver "CYCSA" text painted. 1 anode on the existing train wheel loop replaced. All components are in good condition. Rope and buoy were cleaned. Consider replacing train wheel with truck tire filled with concrete as train wheel loops deteriorating.

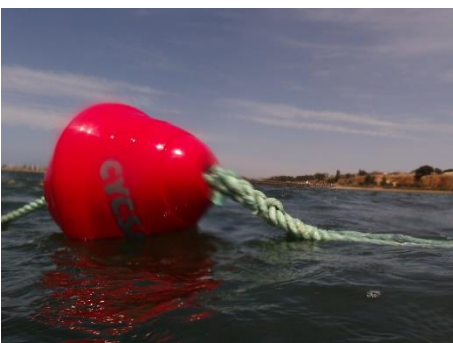
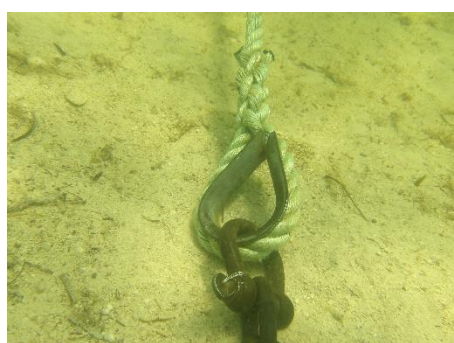
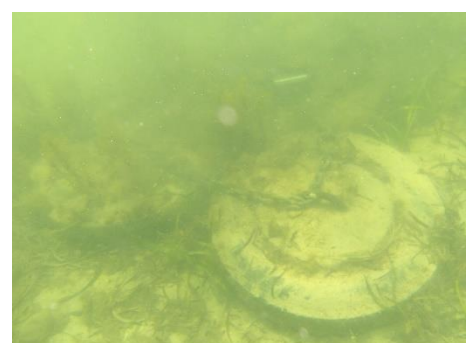
## South

**Description:** 2 truck tires filled with concrete and 1 train wheel (existing) (approx. 400 to 450 kgs each). 12m of 20mm chain (galv), 15m of 32mm green supertec rope, 1 rope weight. Red mooring buoy with silver "CYCSA" text painted. 1 anode on the existing train wheel loop replaced. All components in good condition. Rope and buoy were cleaned. Consider replacing train wheel with truck tire filled with concrete as train wheel loops deteriorating.

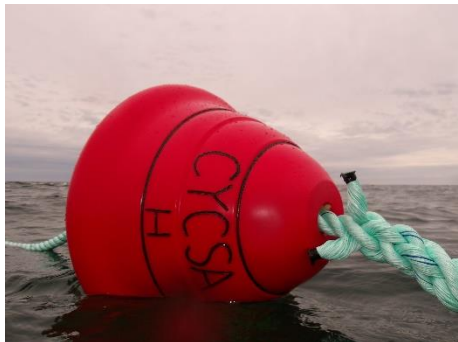
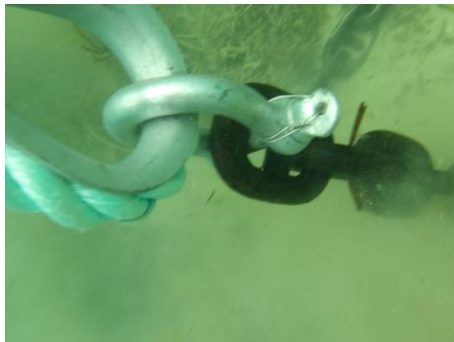
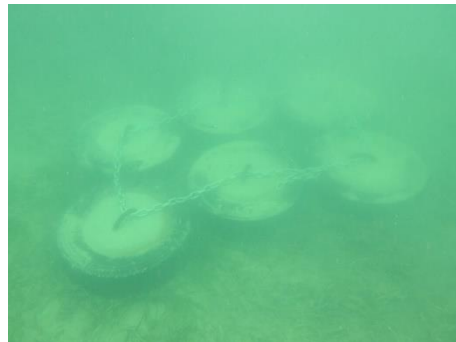
### Mega mooring

**Description:** 6 truck tires filled with concrete (approximately 400 to 450 kgs each), 2500kg (approx.), total. 13m of 28mm stud link chain, 15m of 32mm green supertec rope, 1 rope weight. Red mooring buoy with black lines and "CYCSA H" text. Installed on 04/08/2024.

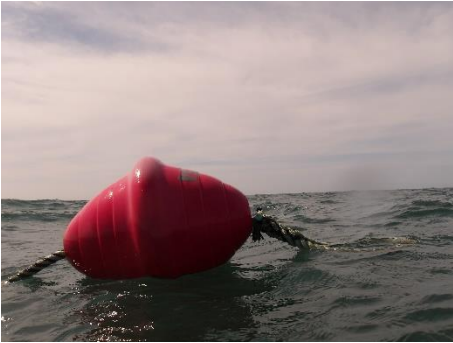
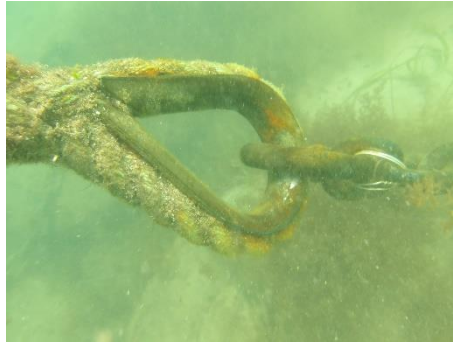
### North West (previously North)

**Description:** 3 truck tires filled with concrete (approximately 400 to 450 kgs each). 12m of 20mm chain (galv), 15m of 32mm green supertec rope, 1 rope weight. Red mooring buoy with silver "CYCSA" text painted. All components are in good condition. Rope and buoy were cleaned.

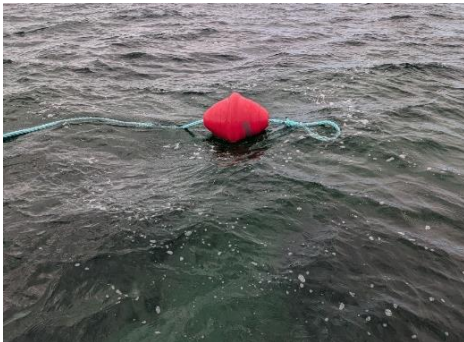
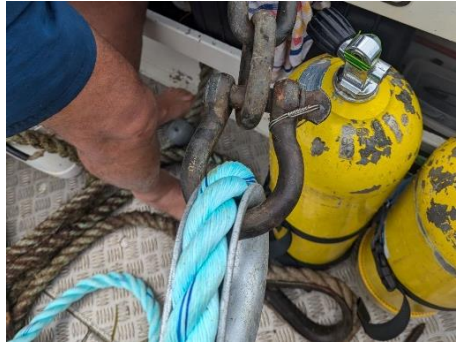
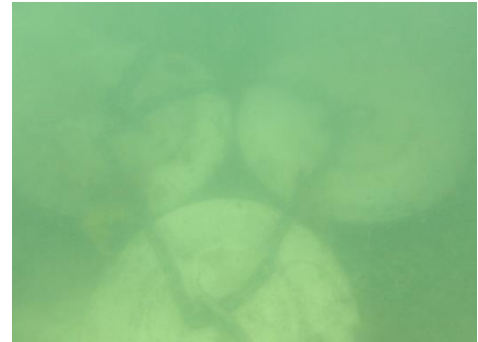
### North East (previously Mid)

**Description:** 3 truck tires filled with concrete (approximately 400 to 450 kgs each). 12m of 20mm chain (galv), 15m of 32mm green supertec rope, 1 rope weight. Red mooring buoy with black "CYCSA" text engraved. All components are in good condition. Replaced rope due to damage.

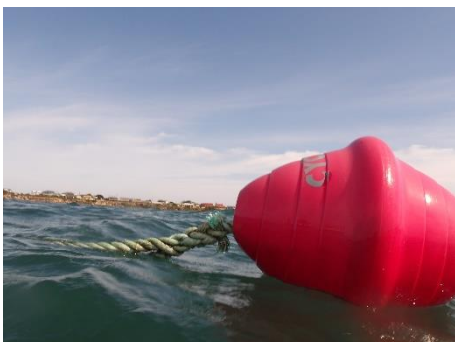
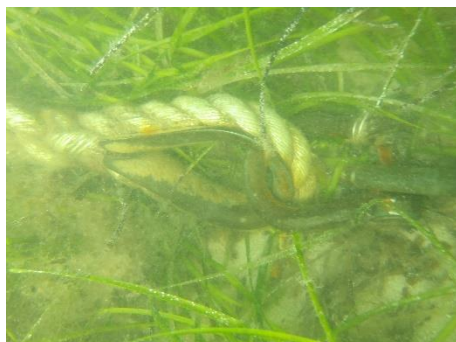
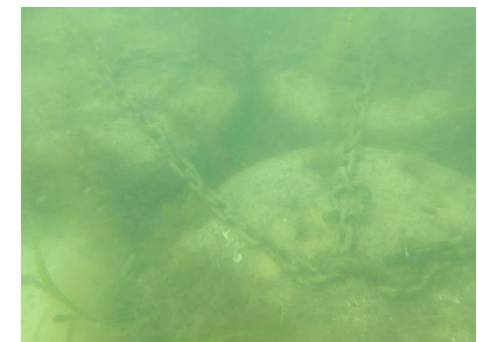
### South

**Description:** 3 truck tires filled with concrete (approximately 400 to 450 kgs each). 12m of 20mm chain (galv), 15m of 32mm green supertec rope, 1 rope weight. Red mooring buoy with silver "CYCSA" text painted. All components are in good condition. Reinstated loop which had pulled through buoy. Rope and buoy were cleaned.
